CRWR Online Report 12-06

Bathymetric Survey of Imja Lake, Nepal in 2012

January 2013

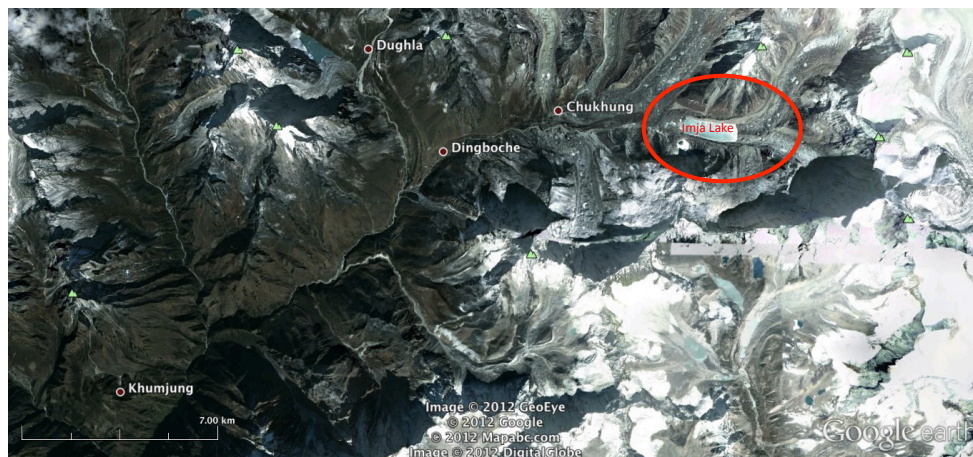
Figure 2. Location of Imja Lake (Source: Google Earth, 2010)

Hammond (1988) identified twenty-four glacier lakes and numerous other melt water ponds in the Khumbu region in 1988. Most of these lakes began forming in the late 1950s to early 1960s and have expanded considerably ever since, especially the supraglacial Imja Lake (see Figure 2). The original 1963 Schneider map of the Everest region does not show a supraglacial lake on the Imja Glacier, but it does show five large ponds on the surface of the glacier (Hagen et al. 1963). The lake has experienced rapid growth in area and volume since in the early 1960's, leading to concern about the risk of a catastrophic GLOF event. Watanabe et al. (2009) provide a full account of the growth and development of Imja Lake. Bolch et al. (2011) studied the mass change for ten glaciers in the Khumbu region south and west of Mt. Everest. The Imja glacier area (including the Lhotse Shar glacier) was found to be 10.7 km^2 (in 2007) with a specific mass balance of $-0.5 \pm 0.09 \text{ m/yr}$, the largest loss rate in the Khumbu region. The high mass loss rate of the Imja glacier results from a complex mixture of processes including calving losses at the glacier terminus along with large areas of the glacier surface with comparatively thin debris cover.

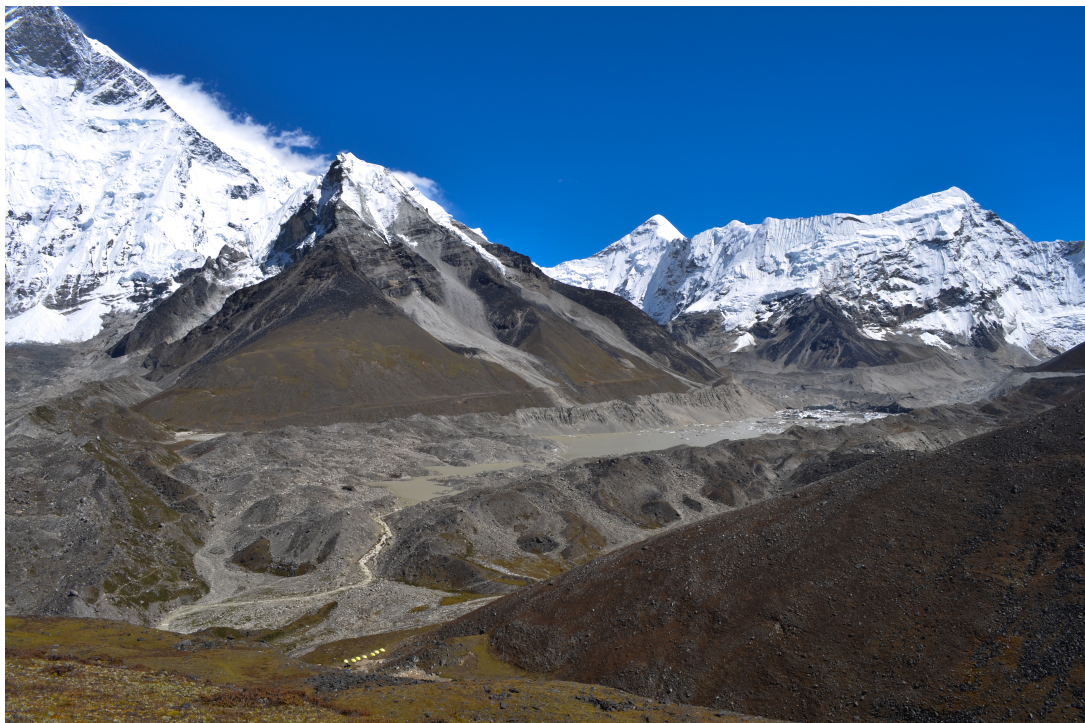
Figure 3. Imja Lake, September 2012 (*Photo: Daene McKinney*)

Imja Lake is located in the Khumbu region of the Nepal Himalaya (27.898 N, 86.928 E), about 9 km south of Mt. Everest. The lake is bounded on the east by the Imja Glacier, on the north and south by lateral moraines, and to the west by a terminal moraine (Figure 3). Imja Lake is dammed by an 700 m wide by 600 m long ice-cored terminal moraine complex through which water exits the lake by means of an outlet lake complex (Watanabe et al. 1994; Watanabe et al. 1995; Somos et al. 2012). The incision of the outlet channel complex has lowered the lake level by some 37 m over the last four decades (Hambrey et al., 2008; Watanabe et al., 2009; Lamsal et al, 2011). The terminal moraine clearly still contains ice evidenced by outcrops of bare ice, ponds formed by melt water from ice in the moraine (Figure 4), and traces of old ponds (Somos et al. 2012; Yamada & Sharma 1993). It is likely that the outlet lake complex is evolving into a new arm of the lake (Benn et al 2012). The outlet flow from the lake forms the Imja Khola (river), which is a tributary of the Dudh Khosi. The area of the Imja basin is about 141 km² with altitude ranging from 4355 to 8501 m and it is about 38% covered by glaciers (Konz et al., 2005).

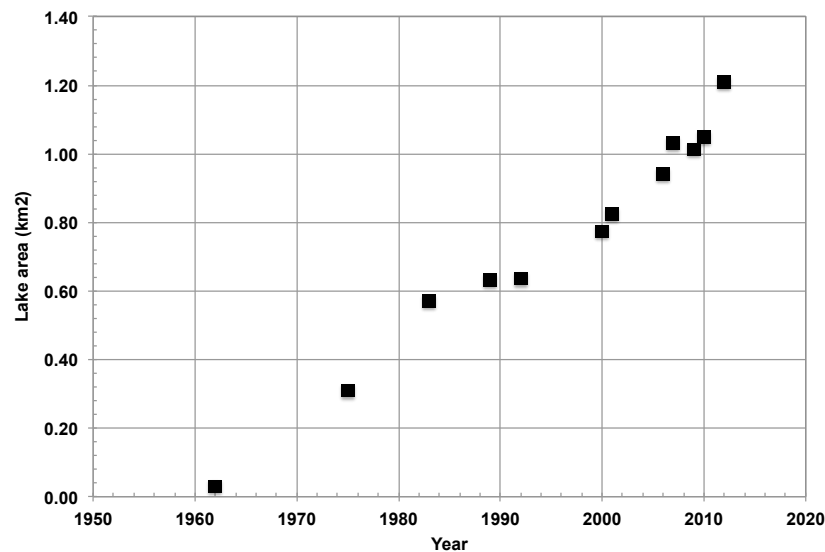
Figure 5. Imja Lake Expansion 1962-2012.

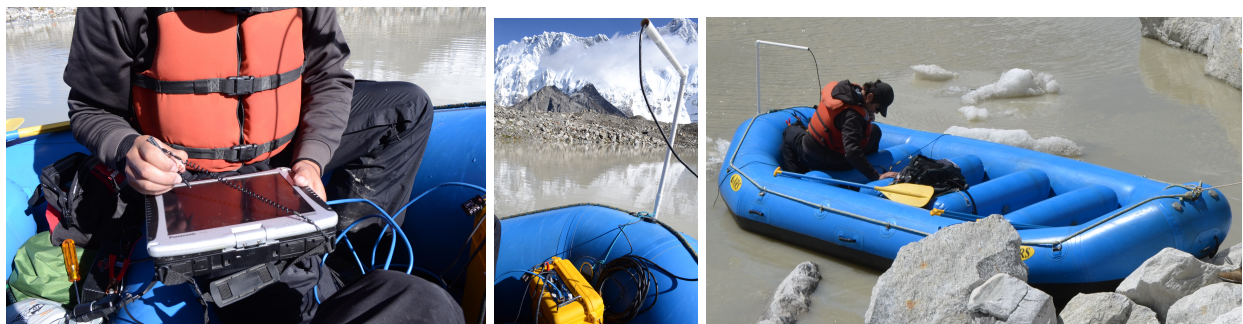
Figure 6. The EchoSounder sonar equipment in the inflatable boat at Imja Lake (*Photos: Daene McKinney*)

A Biosonic EchoSounder MX system was used to conduct the bathymetric survey. The system consists of three components: (1) a surface unit; (2) a transducer; and (3) a computer. The surface unit operates on 12v DC power and is contained in a protective case that houses the sonar transmitter and provides power and data connection to the transducer. The surface unit generates and receives information from the transducer, processes the signal into a usable format, combines GPS data from an internal Garmin GPS 15xH unit and transmits the raw data to the computer. The transmitter generates the sonar pulse and sends the signal to the transducer. The transducer converts the signal from the transmitter into an acoustic pulse and transmits that energy into the water. The transducer also receives acoustic echos and converts them to electrical signals and transmits them to the surface unit through the transducer cable. A Panasonic Toughbook laptop computer is used to run the visual acquisition software to process the data received from the transducer and surface unit. The transducer is mounted on a pole connected to the rear of the boat. The system produces a ping rate of 5Hz, and an accuracy of 1.7cm +/- 0.2% of depth, with a depth range of 0-100m. The transducer has a single frequency – 204.8 kHz with a beam angle of 8.5 degree. Figure 6 shows the EchoSounder sonar equipment in the boat at Imja Lake.

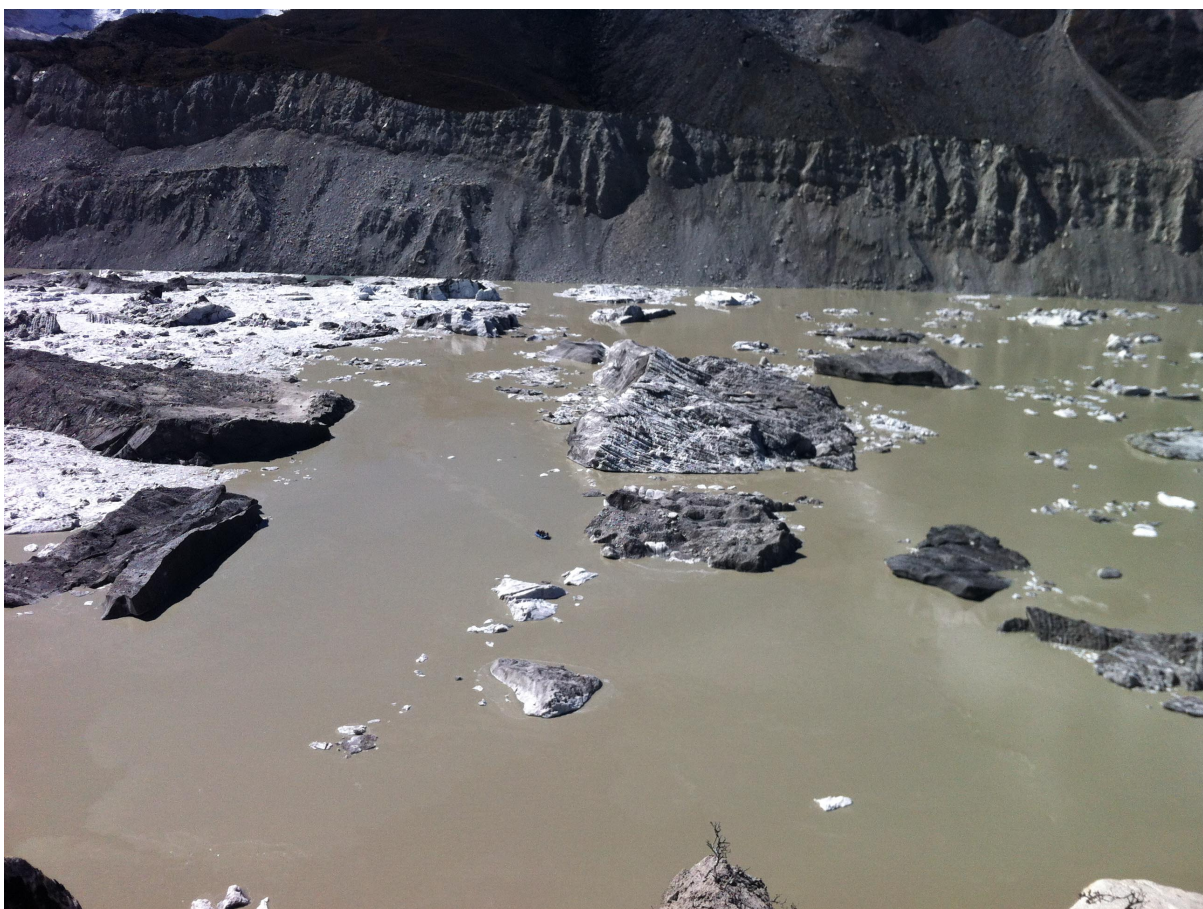
Figure 7. Icebergs present in Imja Lake during Bathymetric survey. (*Photo: Mark Woods*)

One of the unexpected situations encountered during the survey was the massive wastage of the Imja Glacier into the up-glacier end of the lake due to calving of the glacier between May and September 2012 (see Figure 7). This made the approach to the ice cliff at the east end of the lake impossible and very dangerous, so this was not attempted. Figure 8 shows the Imja Glacier end of the lake during September 2011 (top) with most of the glacier cliff intact and again in September 2012 (bottom) with a considerable amount of the cliff calved off into the lake. The retreat of the glacier was very rapid during this period and this is still being analyzed since it was a significantly greater recession than has been observed in previous years and may represent an accelerating process of glacier recession. Another unexpected event was that the lake was not expected to be deeper than 100 m.

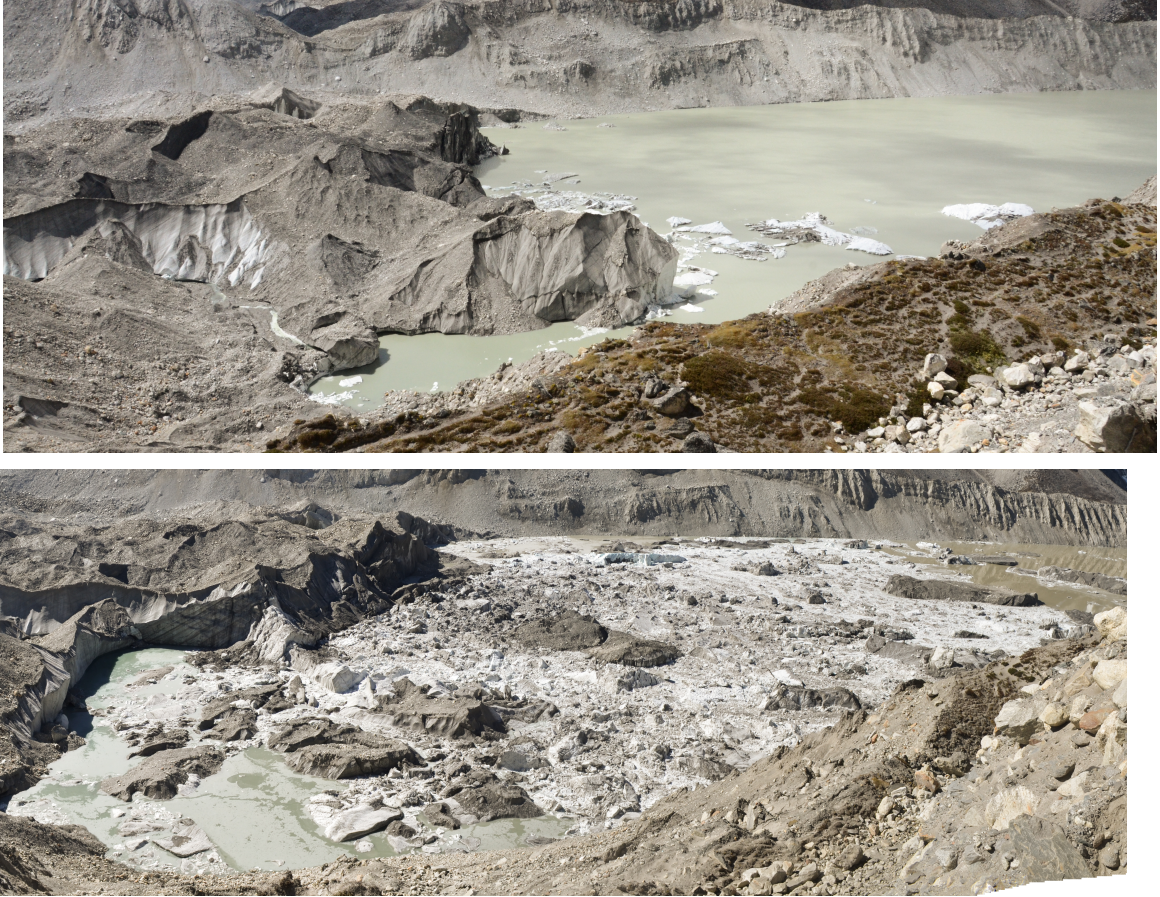
Figure 8. Glacier end of Imja Lake September 2011 (top) and 2012 (bottom). (*Photos: Daene McKinney*)

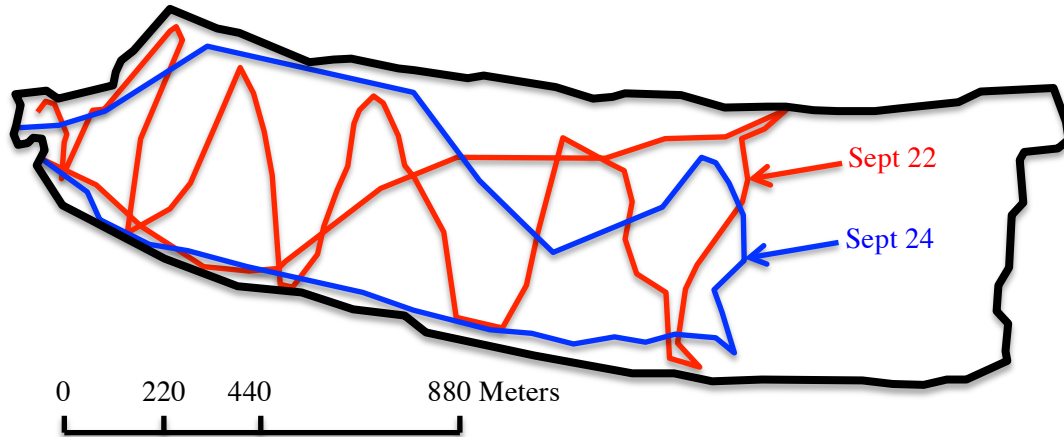
Figure 9. Transects performed during Imja Lake bathymetric survey on September 22, 2012 (Red) and September 24, 2012 (Blue).

Several transects with the sonar system in the inflatable boat were made across the lake and the lake outlet complex on the terminal moraine of the lake (Figure 9). Floating ice that had calved off from the glacier was a constant concern during the survey, since a collision with an iceberg could damage the sonar equipment or sink the boat (Figure 10). Getting too close to the shore was also a major hazard since the sonar sensor could hit the shallow bottom there and become damaged and there are regular rock avalanches into the lake from the very tall and unstable lateral moraines of the former glacier. At the beginning of the survey each morning about 2 cm of ice covered the lake surface, making rowing difficult.

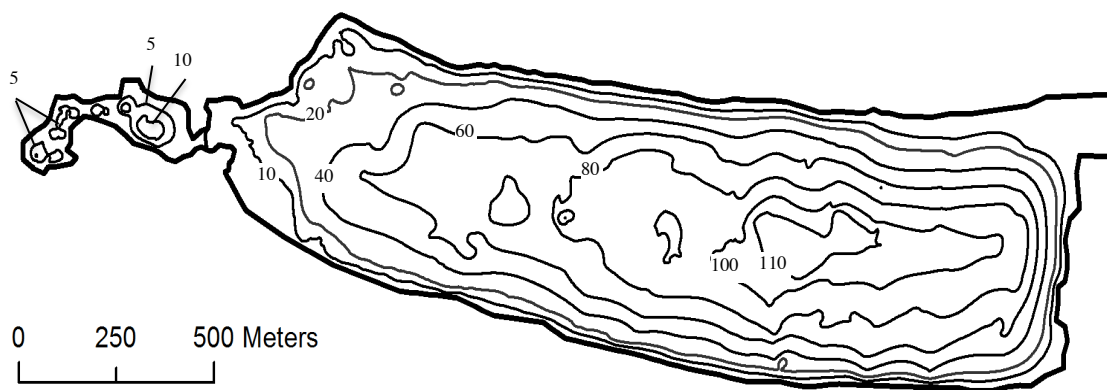
Figure 11. Bathymetric survey results from Imja Lake.

Figure 11 shows a contour map of the depth of the bottom of Imja Lake derived by interpolating the sonar measurements. During the transects back and forth across the lake, water depths of 20-60 m were measured near the western edge of the lake (outlet end) and 30-100+ m deep near the eastern (glacier) end of the lake. Due to the thick iceberg coverage on the eastern edge of the lake, transects at the far eastern end of the lake were not possible. Elevations deeper than 100 m within the 100m-contour have been interpolated from the surrounding values and the slope at the up-glacier end (eastern) of the lake has also been approximated. It is very clear, when compared to the previous surveys (Yamada & Sharma 1993; Sakai et al. 2003; ICIMOD 2011) that the lake bottom has continued to deepen as the ice beneath the lake has melted (this will be discussed in more detail below).

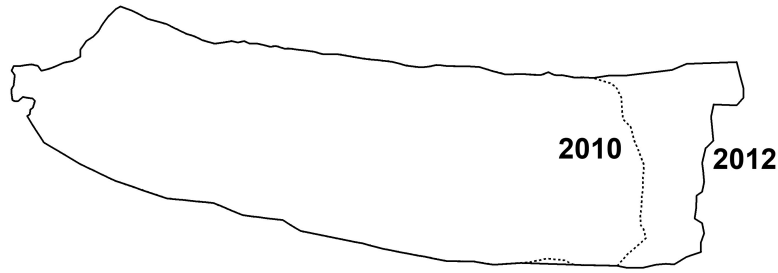
Figure 12. Outline of Imja Lake in February 2010 (area=1.056 km², *Source*: Google Earth) and June 2012 (area=1.2135 km², *Source*: Global Land Ice Measurements from Space, www.glims.org and ASTER/JPL/NASA).

The previous maximum depth measured in bathymetric surveys was 98 m (Yamada & Sharma, 1993). The maximum depth measured by the sonar sensor in this bathymetric survey was 100 m, but a maximum depth was approximated from the sonar data by interpolation as 116 m. The data presented here significantly change the estimate of the volume of water in the lake from 35.5 million m^3 estimated in 2009 (ICIMOD 2011) to 63.8 million m^3 from this survey, almost double the previous estimate. The 2009 estimate (ICIMOD 2011) of the lake volume is less than that estimated in 2002 (Sakai et al. 2003), possibly because it had to be completed by hand (ICIMOD 2011). In any case, the 2002 volume estimate was 35.8 million m^3 . Figure 12 shows the outline of Imja Lake in February 2010 when the area was 1.056 km^2 , and again in June 2012 when area was 1.214 km^2 .

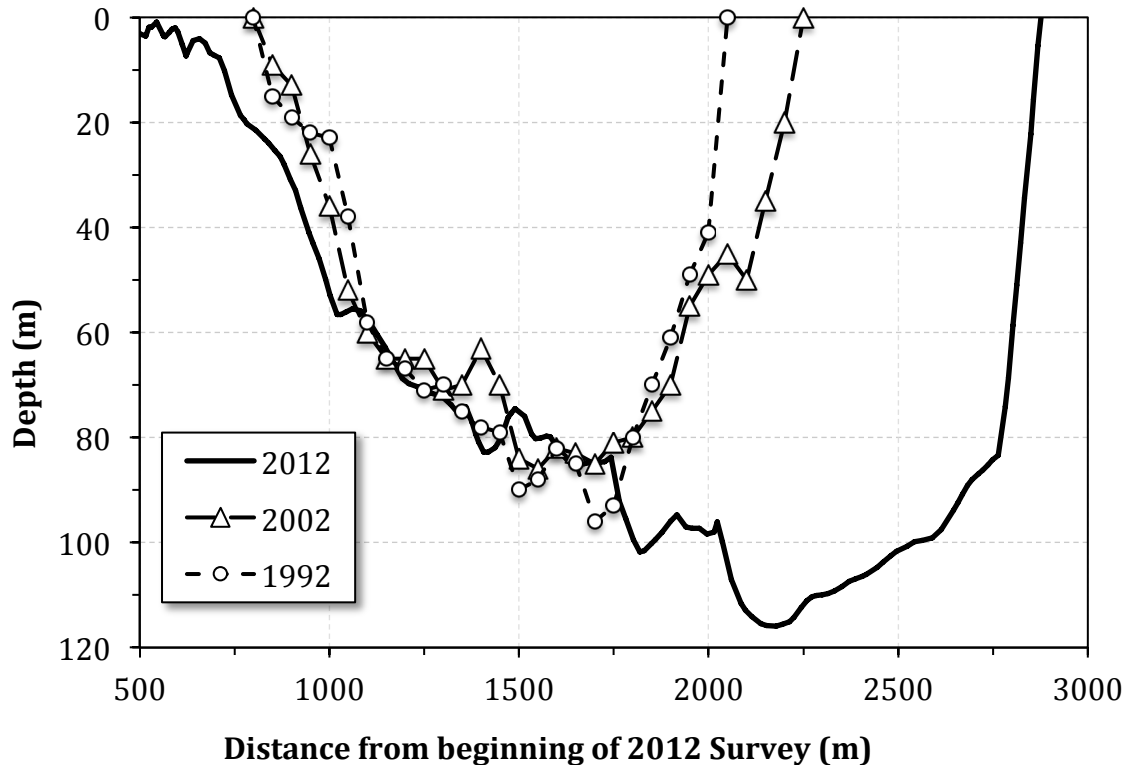
Figure 13. Comparison of 2012 bathymetric survey results with those of the 1992 (Yamada & Sharma 1993) and 2002 (Sakai et al. 2003) surveys.

Figure 13 shows a comparison of 2012 bathymetric survey results with those of the 1992 (Yamada & Sharma 1993) and 2002 (Sakai et al. 2003) surveys. The up-glacier expansion of the lake is evident in the figure as well as the rapid retreat of the glacier ice cliff and the major subaqueous melting that has taken place. Sakai et al. (2005) found that the bathymetric

expansion of Imja Lake was mainly the result of glacier retreat. They assumed that the water level in 1992 was equal to that in 2002, and their cross sections revealed no great difference from the outlet to the glacier cliff between 1992 and 2002, as shown in Figure 13). The shallower depth recorded in 2002 may be a result of abundant sediment produced at the base of the glacier and carried away by glacier melt water and deposited in the lake basin or possible locational error (Sakai et al. 2003). This is also the likely reason for the discrepancies between the curves in Figure 13 up to 1750 m. Beyond that point, the lake has deepened significantly due to subaqueous melting and calving.

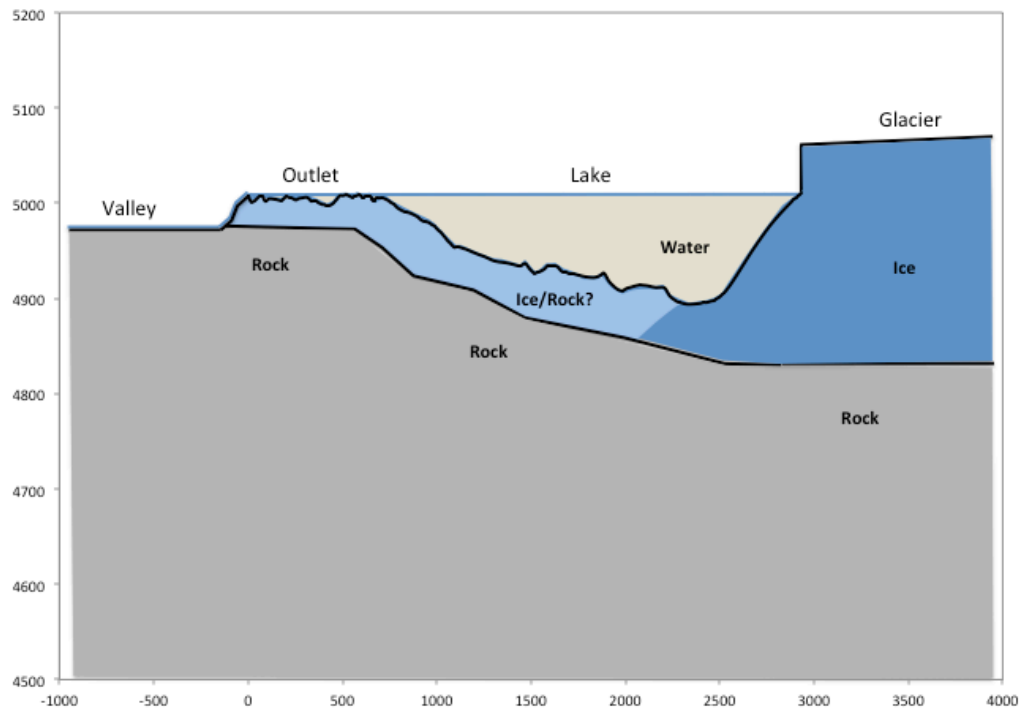
Figure 14. Conceptual model cross-section of Imja Lake based on bathymetric survey and ground penetrating radar surveys. (5x vertical exaggeration).

Figure 14 illustrates a conceptual model cross-section of Imja Lake based on this bathymetric survey and ground penetrating radar (GPR) surveys described in Somos et al. (2012). The thickness of the ice near the face of the Imja Glacier is about 220 m, about 73 m below the

bottom of Imja Lake. It is clear that the ice beneath the bottom of the lake continues to melt, but the thickness of that ice is unknown. The previous GPR surveys have indicated the presence of extensive ice up to 60 m thick in some areas of the outlet complex and terminal moraine. The transition from relatively clean glacier ice to the ice and rock mixture of the outlet complex is unknown but may be significant toward the up-glacier end of the lake since the bottom topography near the outlet end of the lake has not changed much over the past decade.

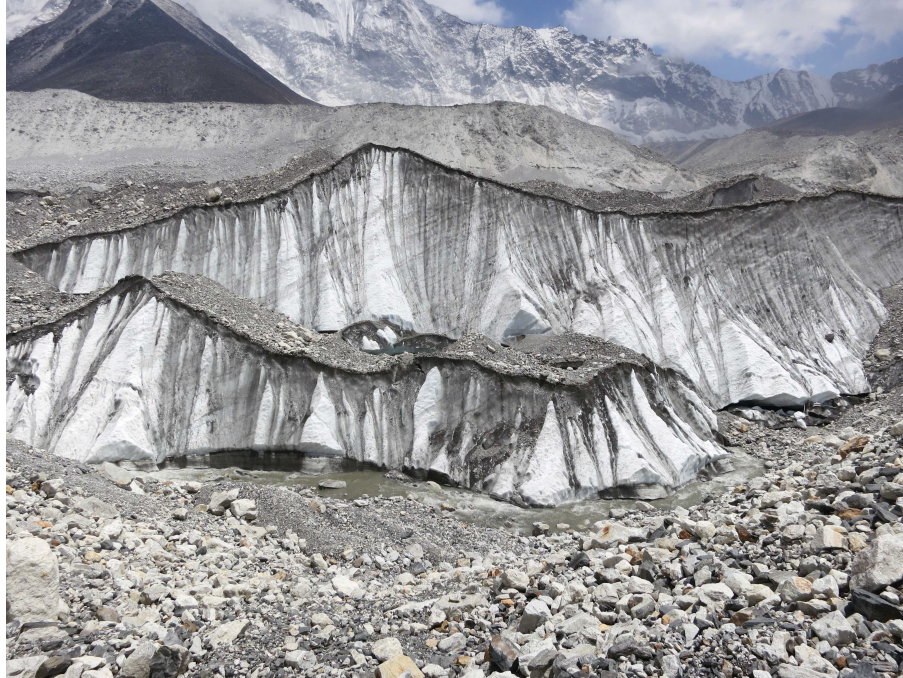
Figure 15. Imja Glacier showing the thin covering of debris and the clean ice structure beneath.
(Photo: Daene McKinney)

Average growth rate: ICIMOD (2011) shows values for the average growth rate of Imja Lake. For the period 1962 – 2001 the rate is given as 42 m/year and for the period of 2001 – 2006 as 74 m/year. These values are based on the differences in the length of the lake, but the method of measuring the length of the lake is not specified. In this research, the area of the lake in 2010 has been calculated from GIS to be 1.05 km² and in 2012 to be 1.21 km². The average width of the lake has been calculated to be 601 m. Based on these figures, the difference in the area over this two-year period is 0.162 km² and the average growth rate over the period is 135 m/year, significantly in excess of previously reported rates. Benn et al. (2012) note that debris cover on glaciers, especially thin cover, and may cause a strongly non-linear chain of cause and effect of mass loss and lake formation. This may be what has been observed at Imja Lake over the past 2 years. Figure 15 shows the Imja Glacier near its terminus, the thin covering of debris and the clean ice structure beneath.

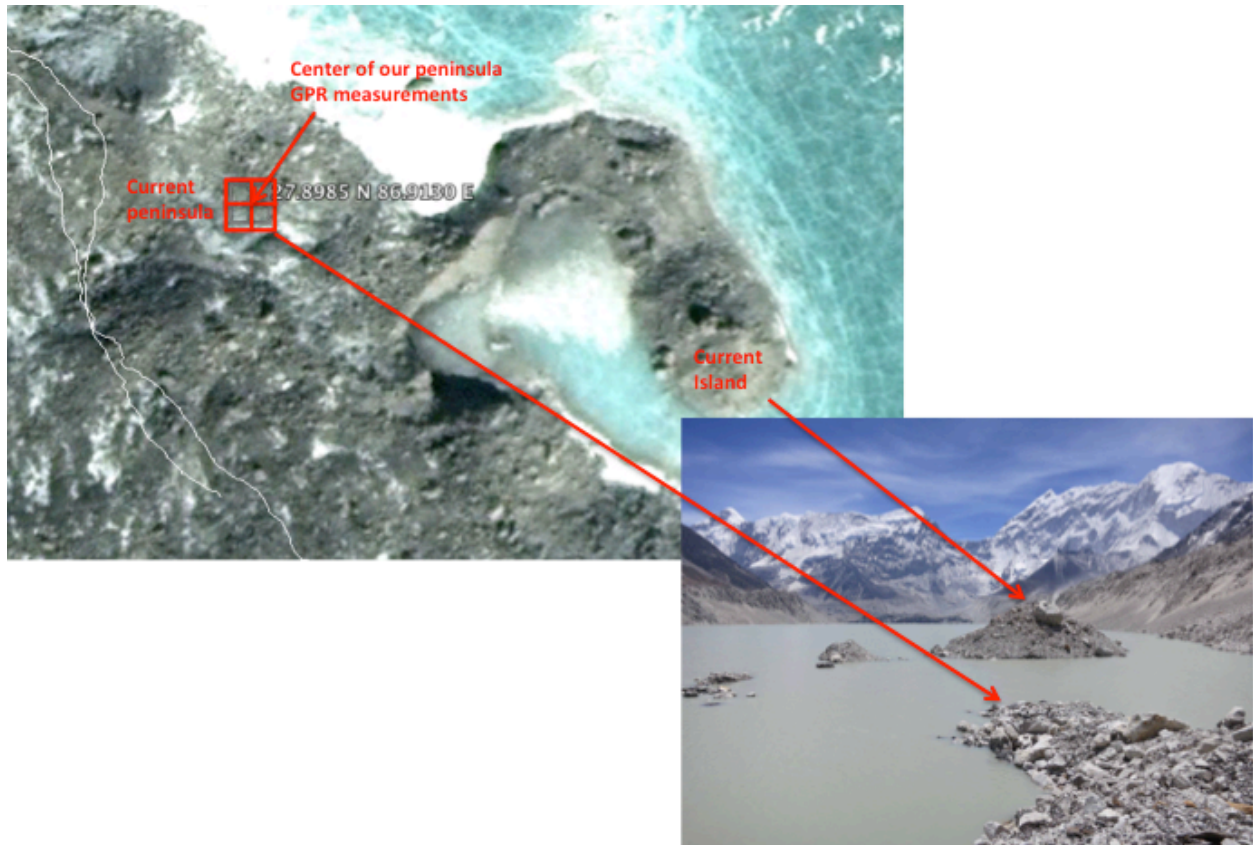
Figure 16. Rapidly disappearing shoreline at the western end of Imja Lake. Left: Google Earth Imagery from February 2, 2010. Right: Photo from May 2012 (*Photo: Daene McKinney*)

Terminal Moraine Shrinkage: The western shoreline of Imja Lake is changing rapidly. Figure 16 shows the rapidly disappearing shoreline at the western end of Imja Lake. The image in the left of the figure (February 2010) shows a major peninsula jutting into the lake from the south side of the lake. The right of the figure shows a photograph of the remains of the peninsula in May 2012, illustrating the rapid decomposition and narrowing of the terminal moraine complex.

observations from field visits in 2011 and 2012 showed the western side of Imja Lake is rapidly transforming (Figures 16 and 17). Small peninsulas apparent in satellite imagery have melted, showing that the terminal moraine is vulnerable and likely undergoing a similar transformation of decomposition and narrowing. Ice cliffs are decomposing into the lake. Small ponds have also been developing throughout the terminal moraine complex. These small ponds are excellent sources of heat to the surrounding ice, which only further exacerbate the decomposition of the terminal moraine complex, yet their development and impact on the terminal moraine complex has not been analyzed. Somos et al. (2012) utilized Ground Penetrating Radar (GPR) throughout the terminal moraine to yield insight into the stability of the ice core beneath the terminal moraine. These results confirmed that there is a large ice core beneath the terminal moraine that is susceptible to melting; however, extensive electrical resistivity surveys are needed to better understand the terminal moraine complex. Further information is needed to assess the current risk and predict the decomposition of the terminal moraine complex in the future, especially as Imja Lake continues to expand rapidly. Furthermore, current risk reduction strategies being pursued through a UNDP Global Environment Facility proposal are to incise a concrete channel into the terminal moraine structure to lower the lake level by 3m. In order to assure that this is an effective risk mitigation strategy, it is imperative to have additional knowledge of the terminal moraine complex. An understanding of the location of ice throughout the entire moraine and the seepage through the moraine is required in order to develop mitigation strategies that will not negatively impact the structure of the terminal moraine.

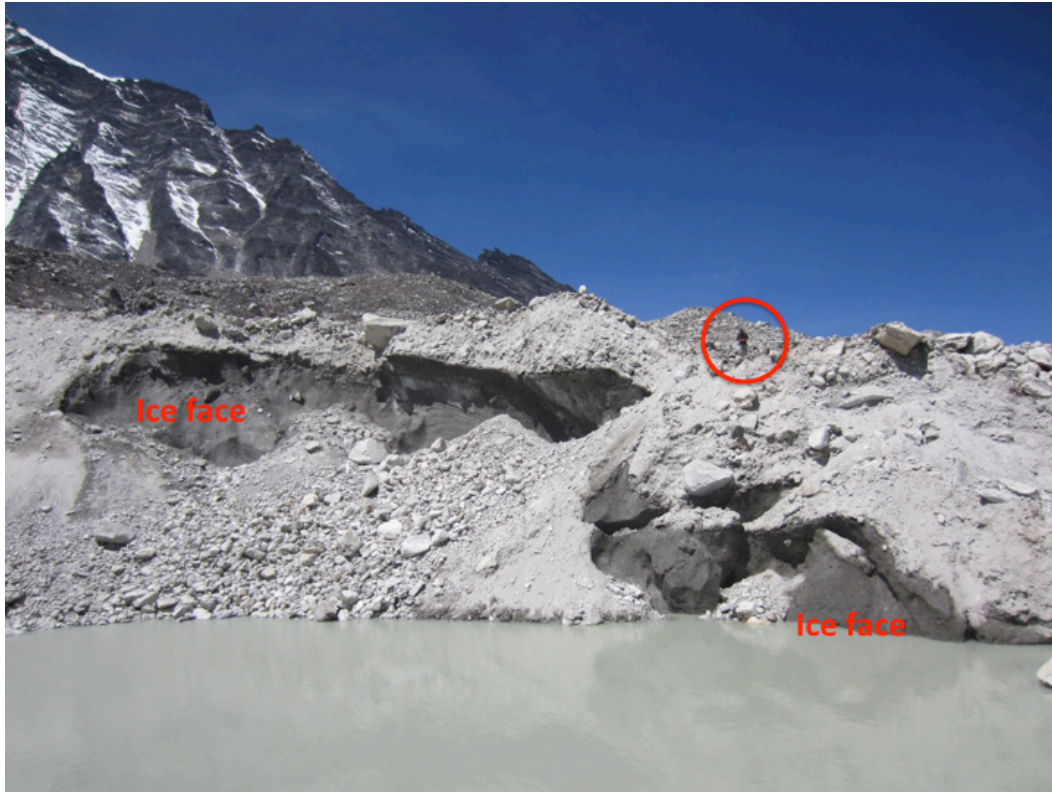
Figure 17. Ice face visible below the top of the left lateral moraine of Imja Lake. The 2 m person is shown in the photo for scale. (*Photo: Marcelo Somos-Valenzuela*)

Figure 17 shows an ice face below the top of the left lateral moraine of Imja Lake on the south side of Imja Lake in May 2012. The ice cliff indicates the presence of large amounts of ice remaining in the core of the moraine and extending into the terminal moraine complex (Somos et al. 2012). The moraine in this area is decomposing rapidly and causing a narrowing of the lateral and terminal moraine in this area. The narrowing of the moraine greatly increases flood risk (Benn et al. 2012); therefore, if this continues it could be major problem in the future.

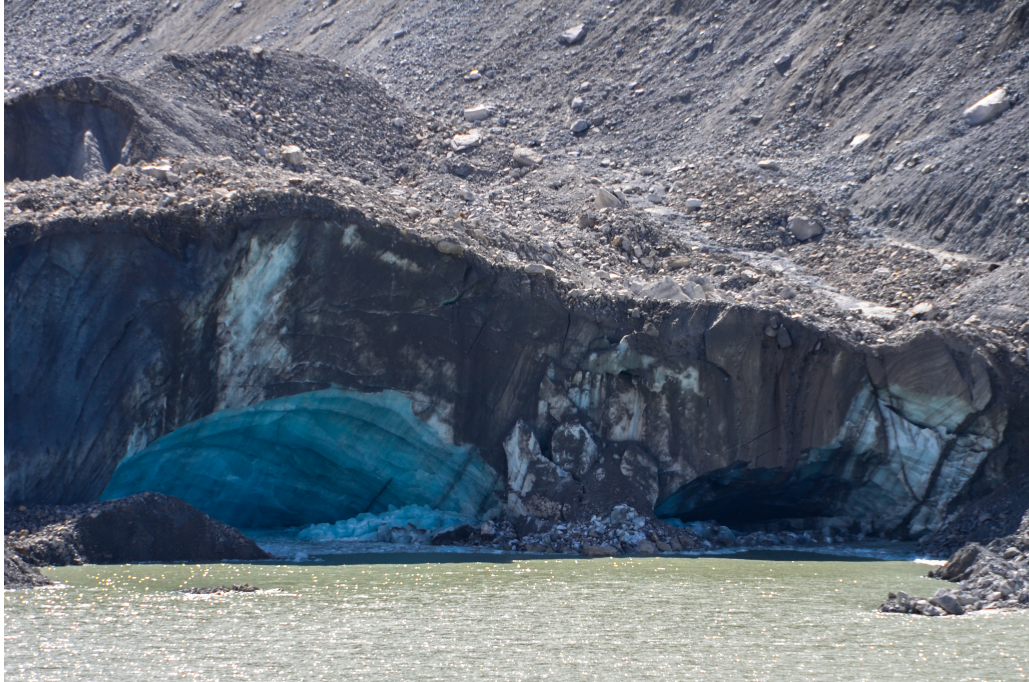
Figure 18. Waterline melting and collapse of the roof of thermo-erosional notches at Imja Lake in September 2011 (*Photo: Daene McKinney*).

Subaerial Cliff Calving: Calving is an important glacier ice-loss mechanism, and can result in larger volumes of ice lost from glaciers than would be possible through surface ablation alone (Boyce et al 2007, Van der Veen, 2002; Benn et al. 2007). Calving mainly affects glacier terminus geometry and retreat rate, and large glaciers calving into deep water tend to lose more mass through calving than ablation (Boyce et al 2007). Calving occurs in a cyclic pattern of melting at the waterline that creates an overhanging subaerial cliff that calves progressively larger ice lamellae by flaking and eventually full height slab calving (Robertson et al. 2012). Kirkbride and Warren (1997) describe four stages of ice cliff calving into glacier lakes and these are illustrated with the authors' observations of these stages at Imja Lake: (1) waterline melting and collapse of the roof of thermo-erosional notches at the cliff foot (Figure 18); (2) calving of ice flakes from the cliff face leading to a growing overhang from the waterline upwards, and crack propagation from the glacier surface (Figure 19); (3) large calving of slabs in response to the developing overhang (Figure 20); (4) subaqueous calving of a submerged ice foot (see Figure 21). The cyclic process of waterline notches growing upwards by flake calving inducing crevasse propagation and full-height slab calving restores the vertical profile to the waterline and forms a submerged ice foot, which experiences subaqueous calving (Kirkbride and Warren 1997).

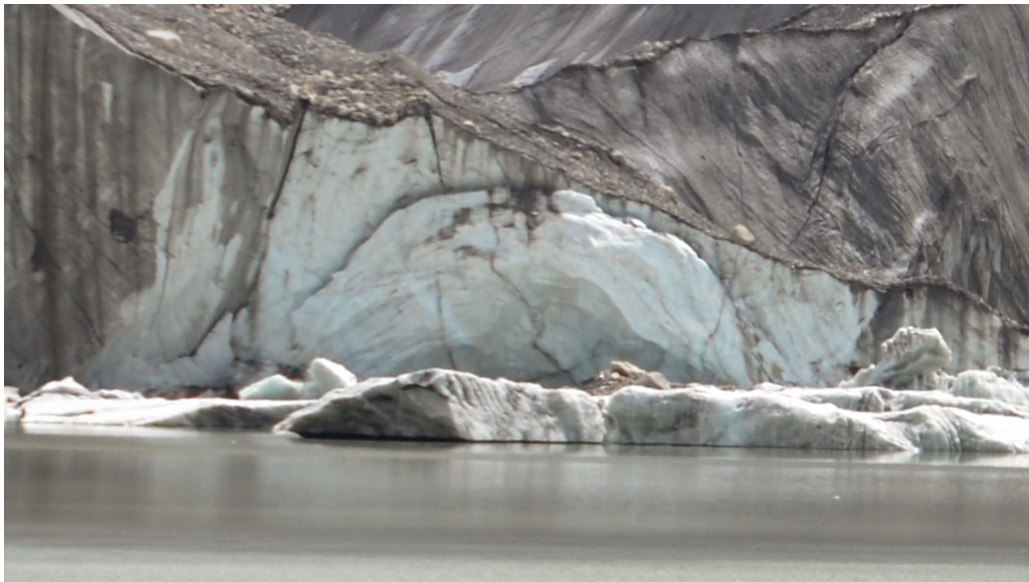
Figure 19. Calving of ice flakes from the cliff face at Imja Lake (*Photo: Daene McKinney*).

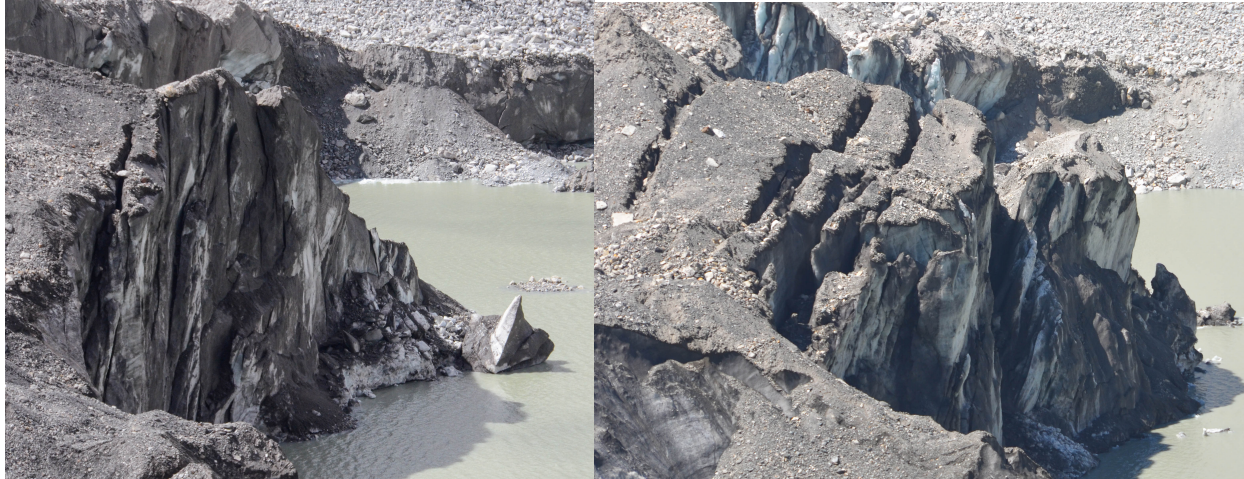
Figure 20. Calving of ice lamella at Imja Lake (left September 2011, right May 2012) showing forward bending causing surface crevasses to propagate downward (*Photo: Daene McKinney*).

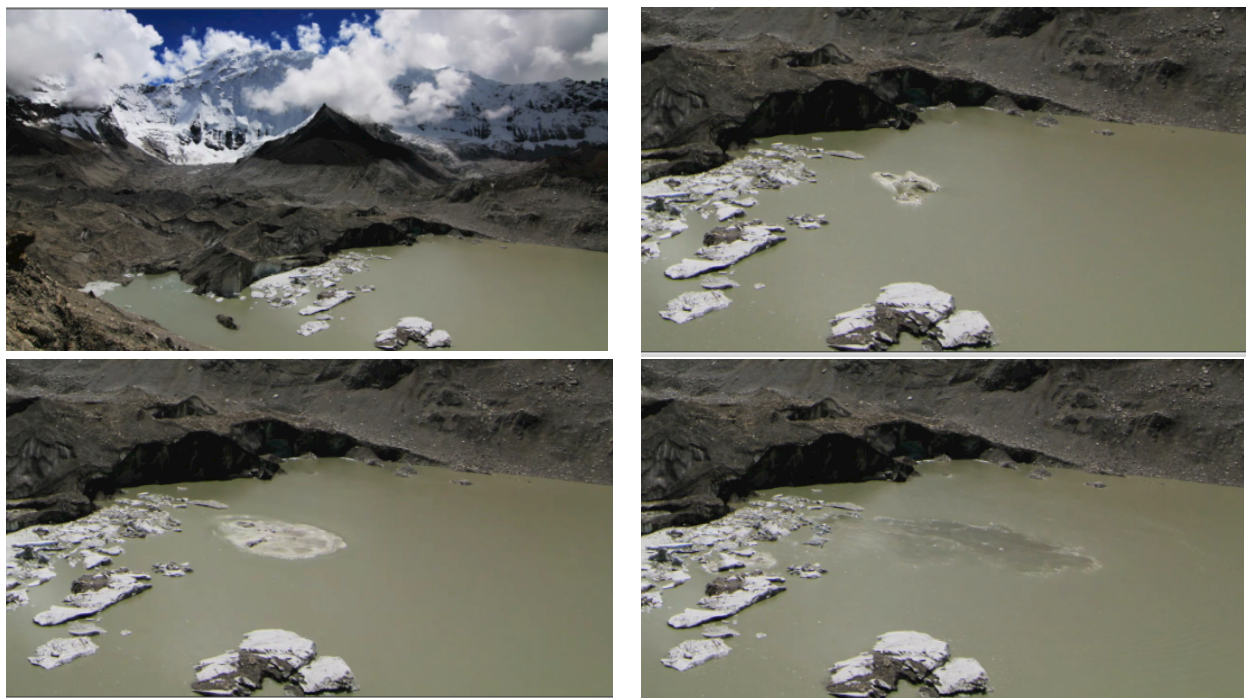
Figure 21. Subaqueous calving event at Imja Lake in September 2011. Upper left – before the commencement of calving. Upper right – appearance of iceberg. Lower left – disintegration of iceberg. Lower right – end of calving event. (*Photos: Daniel A. Byers*)

Subaqueous Calving: According to Robertson et al (2012) subaqueous ice ramps appearing at the glacier end of glacier lakes tend to be sloped upwards at between 11° and 30° and exhibit subaqueous calving. The distance between the 110 m depth contour and the 20 m depth contour (Figure 11) on the glacier end of Imja Lake (90 m depth difference) is 453 m, giving a slope of 11° . Figure 6 in Sakai et al. (2005) shows that the slope of the bottom of the lake at the glacier end was 12° in both the 1992 and 2002 surveys. The rate of deepening of Imja Lake is far in excess of the rate that would be expected if the controlling process was the melting of underlying glacier ice into the lake. Subaqueous calving may explain the rapid deepening. The authors observed subaqueous calving at the glacier end of Imja Lake in September 2011 (Figure 21 and Byers 2011). The bergs, which most likely detached from a submerged, projecting ice foot or ramp, broke the lake surface at distances of up to 200 m from the ice cliff, from water about 75 m deep. This is similar to subaqueous calving events observed by Kirkbride & Warren (1997) for New Zealand lake-terminating glaciers.

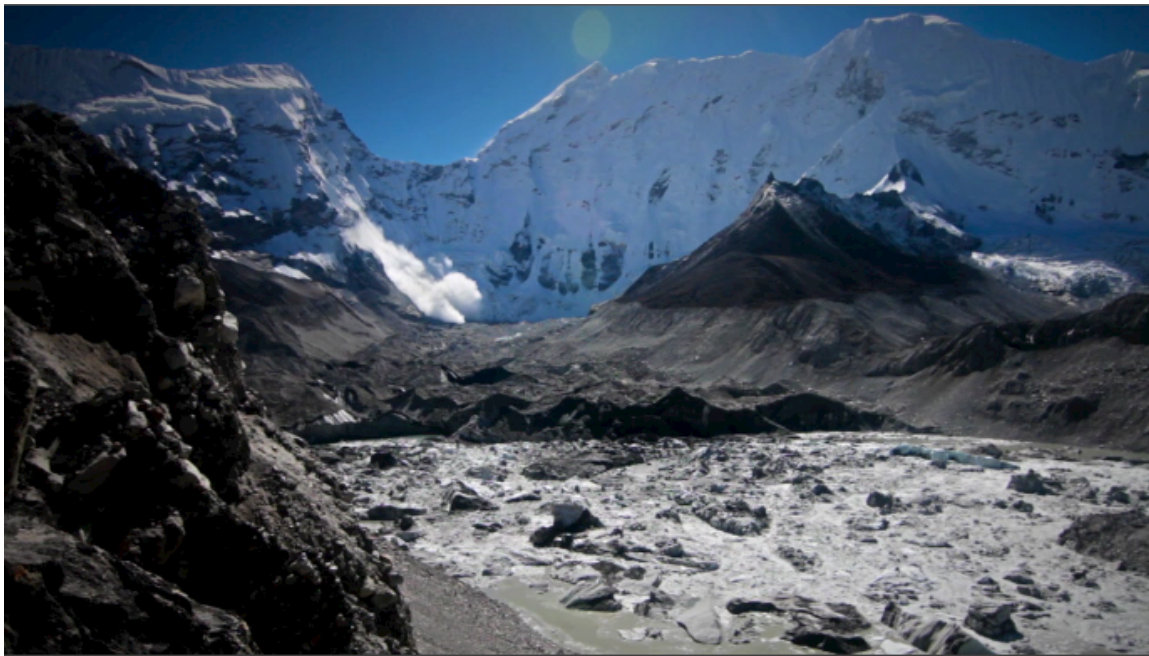
Figure 22. Avalanche onto the Imja Glacier September 2012 (*Photo: Daniel A. Byers*)
